## AVIATION INVESTIGATION REPORT

A99P0075

### POWER LOSS—FUEL STARVATION

EAST WEST HELICOPTERS LTD.  
BELL 214B HELICOPTER C-GEWT  
KASLO, BRITISH COLUMBIA 35 NM NW  
4 JULY 1999

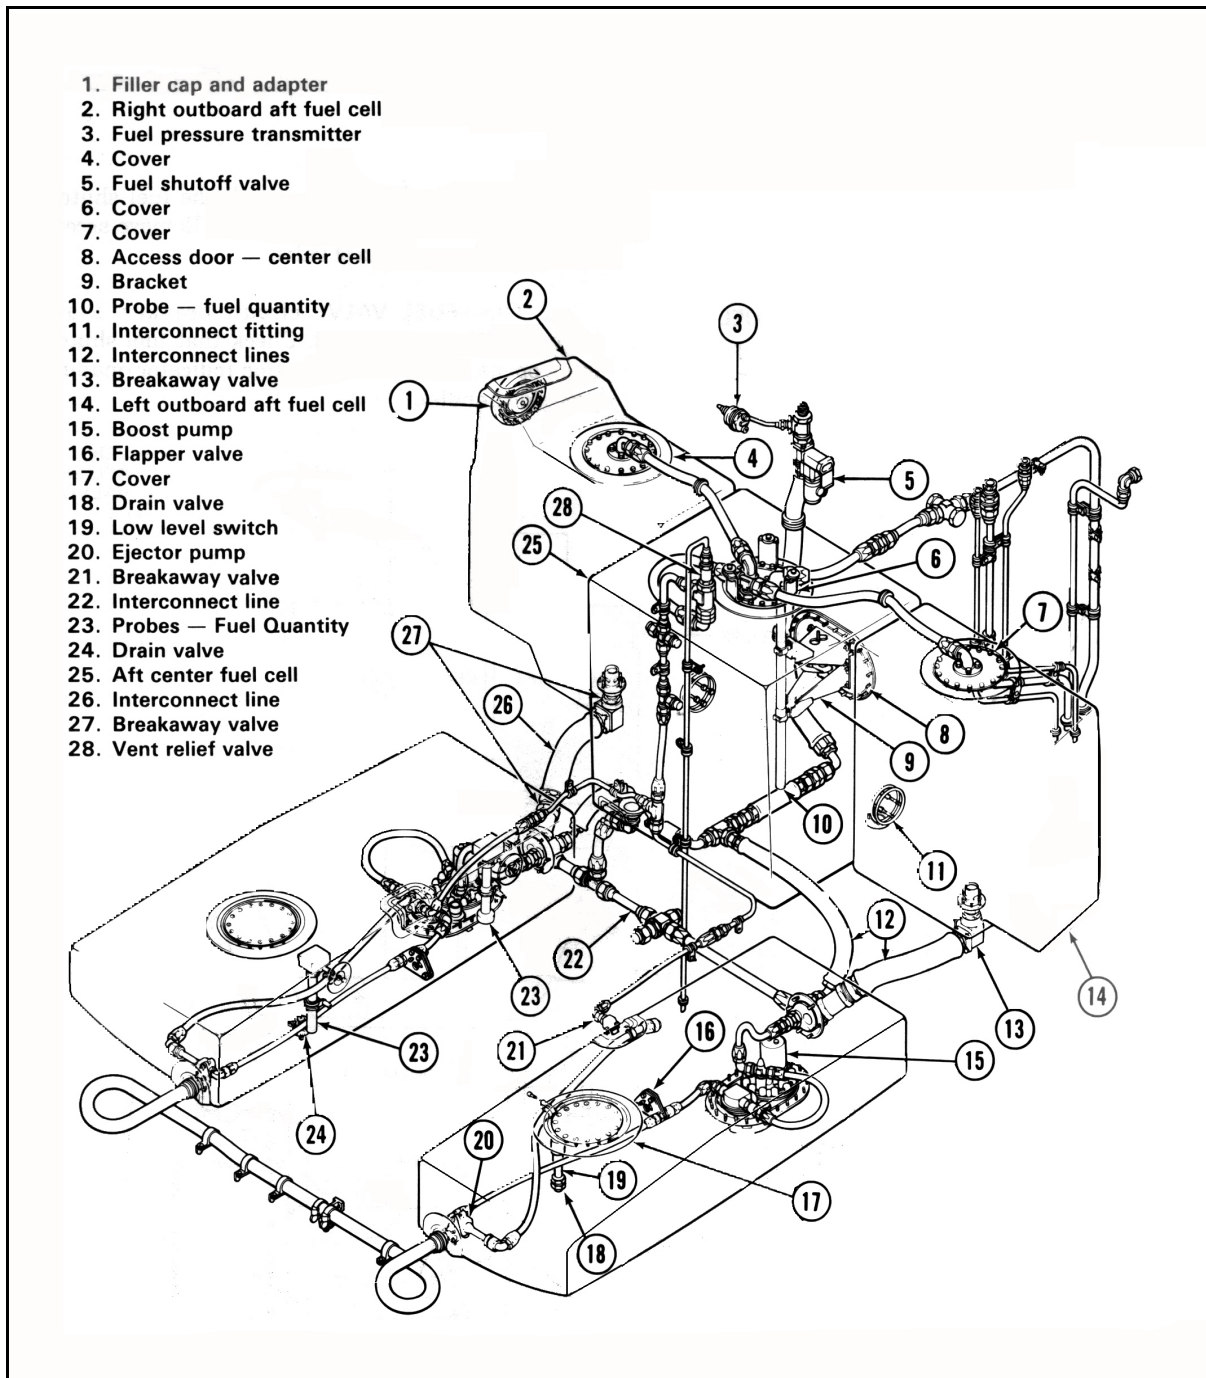
Figure 1 - Fuel System on Bell 214B Helicopter

The Bell 214B helicopter is equipped with five fuel cells interconnected to feed into the two forward fuel cells, which are the lowest cells in the system (see Figure 1). Each of the forward cells has a partition with a small one-way flapper valve, which divides the cell into a forward and an aft section. The aft section of each forward cell contains an electrically driven boost pump, part number 164A213, which supplies fuel to the engine. Each boost pump also operates a jet pump, located in the forward section of each cell, to supply fuel from the forward section of the cell to the aft section. A fuel cell interconnect line runs between the left and right forward fuel cells, normally ensuring that the fuel level in the two forward cells remains equal. The fuel quantity gauge is operated by probes located in the centre cell and the right forward fuel cell. If the centre fuel cell does not contain any fuel, the fuel quantity gauge is operated solely by the probes in the right forward cell. The fuel quantity gauge does not directly register fuel in the left forward cell. The left forward fuel cell contains a float-switch used to activate the low-fuel warning light. The Bell 205 has similar fuel storage, fuel transfer, and fuel indicating systems.

The light bulb analysis showed that the low-fuel light and the right boost pump annunciator light might have been illuminated at the time of the crash. The fuel level sensor is in the left forward cell; therefore, the low-fuel light would indicate that the left forward cell was virtually empty. Assuming the right boost pump became inoperative, the fuel from the left forward cell was consumed at a faster rate than the fuel could transfer from the right forward cell to the left forward cell. The fuel in the left forward cell eventually reached an unusable level, and the engine stopped. The fuel gauge indicator retains its last position when power is cut off. The gauge indication after the crash was 500 pounds. Assuming that power was lost at impact, the gauge was indicating 500 pounds of fuel just before the crash. Relying on the principle that the fuel in the forward cells will remain equal because of the cell interconnect line, the system measures the amount of fuel in the right forward cell, and doubles that amount for the fuel quantity indicator. Therefore, at the moment of the crash, there was approximately 250 pounds of fuel in the right cell and virtually none in the left cell. The boost pump light would indicate that the right boost pump was not operating or that there was no useable fuel in the right fuel cell. In light of the following, it is likely that the pump was not operating (failed): the engine stopped in flight; nothing mechanically wrong was found with the engine; there was useable fuel in the right cell; and the boost pump light might have been on.

The average length of time that the fuel boost pumps on the Bell 214B were found to operate before requiring repair or overhaul is much lower than the design life goal set by the pump manufacturer. Depending on the attitude of the helicopter, failure of a boost pump in one cell could result in a significant amount of fuel remaining in that cell, while the fuel in the cell with the operable boost pump is consumed to exhaustion. This is because the forward fuel cell interconnect is unable to flow fuel from the cell with the inoperable boost pump to the cell with the operable pump as rapidly as the engine can consume fuel from the cell with the operable boost pump. Exhaustion of the fuel in the cell with the operable boost pump will cause the engine to flame out.

Because the fuel quantity indicating system does not directly measure the amount of fuel in the left forward cell, unless the fuel level in both forward cells is equal, the gauge will indicate an incorrect amount of fuel remaining. For the same reason, the fuel low-level warning system, which does not directly measure the fuel in the right forward cell, can read incorrectly. Either of these indications could lead the pilot to believe that there is more fuel than is actually available and to continue flight operations until fuel exhaustion.
